EVALUATION OF FLAWED COMPOSITE STRUCTURAL COMPONENTS UNDER STATIC AND CYCLIC LOADING

T. R. PORTER

Boeing Aerospace Company
A Division of The Boeing Company
Seattle, Washington

NASA Lewis Research Center Contract NAS3-19709 Gordon T. Smith, Project Engineer

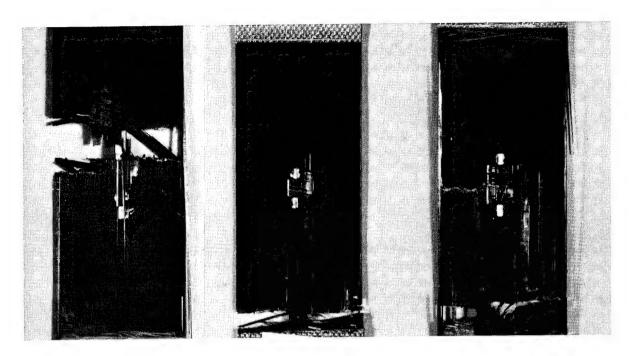
Figure E-9. Laminate L2 Test Specimens Containing a Full- or Half-Penetration Slit

- Specimen L2-1-35
- 1/8 FP slit
- Preload
- 1.5×10^6 cycles
- Residual static

- Specimen L2-1-16
- 3/8 HP slit

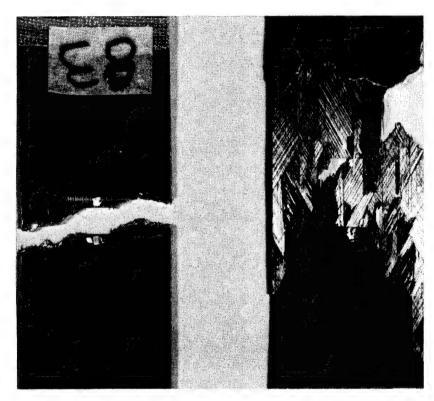
- Specimen L3-2-5
- 5/8 FP slit
- Preload
- Residual static

- Specimen L3-2-6
- 5/8 HP slit
- Static
